Manhole Inspection Summary

Manhole # S41W__034MH

Insp Date: **2/28/08 11:32 AM**

Location Address: **1473 Stevenson Street**

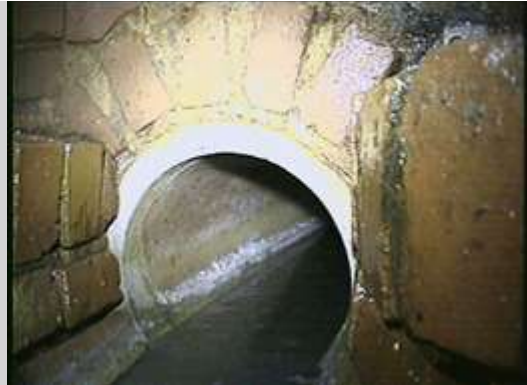
12 O'Clock Outflow

10 in. Circular Gravity Sewer
Pipe Out @ 12 O'Clock

Invert Depth: **13.90** (ft.) Flow Characteristics: **Fast**

Infiltration: **None** Pipe Seal Cond: **Unknown**

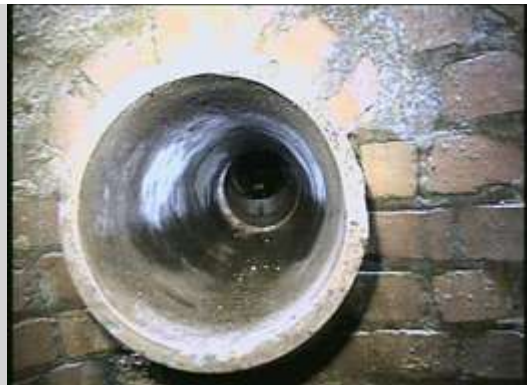
3 O'Clock Inflow

8 in. Circular Gravity Sewer
Pipe In @ 3 O'Clock

Drop In @ 3 O'Clock

Drop: **Outside Direct**

Drop Condition: **Open**

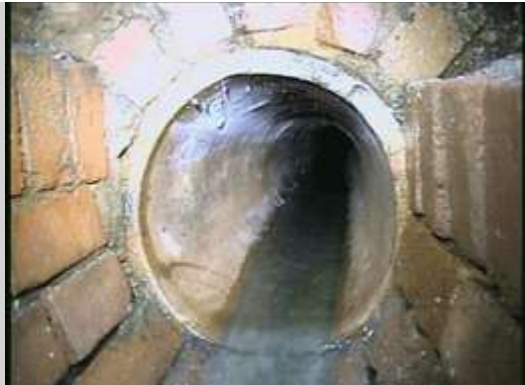
5 O'Clock Inflow

10 in. Circular Gravity Sewer
Pipe In @ 5 O'Clock

Infiltration: **None** Pipe Seal Cond: **Unknown**
